Transportation Safety Board
of Canada

MARINE INVESTIGATION REPORT
M04L0099

COLLISION

BETWEEN THE PLEASURE CRAFT *MONDISY*
AND THE CONTAINER SHIP *CANADA SENATOR*
OFF SAINT-NICOLAS, QUEBEC
11 AUGUST 2004

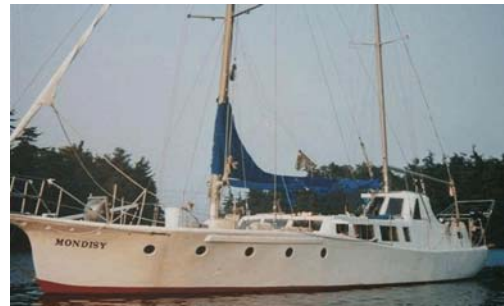
Photo 2. The *Mondisy*

The wreck of the *Mondisy* was salvaged from the river bottom 22 days after the collision in position latitude 46°42'54" N, longitude 071°25'42" W. Damage was extreme as the entire hull had collapsed under the force of the impact with the *Canada Senator*. The laptop computer used for navigation was recovered, but information pertaining to the last voyage was not retrievable from the hard disc because of water damage.
